Effect of steepness of sideslope on rutting

**Research of low-volume roads
HVS-test structures**

Finnra Reports 19/2003

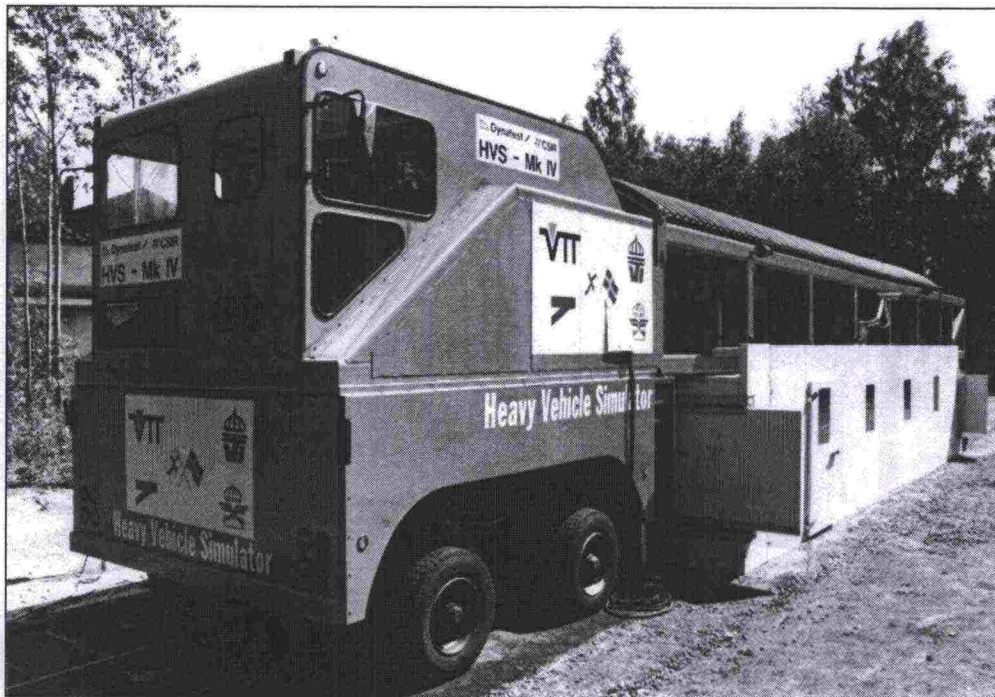
Figure 1.2 The Heavy Vehicle Simulator (HVS).

The maximum load achieved with the simulator is 110 kN and the minimum 25 to 30 kN. The load can be applied on the structure via either a lorry single tyre or twin tyre. The simulator includes a heating/cooling unit for keeping the road structure to be tested at a desired temperature. In this test, the temperature was +10 °C.

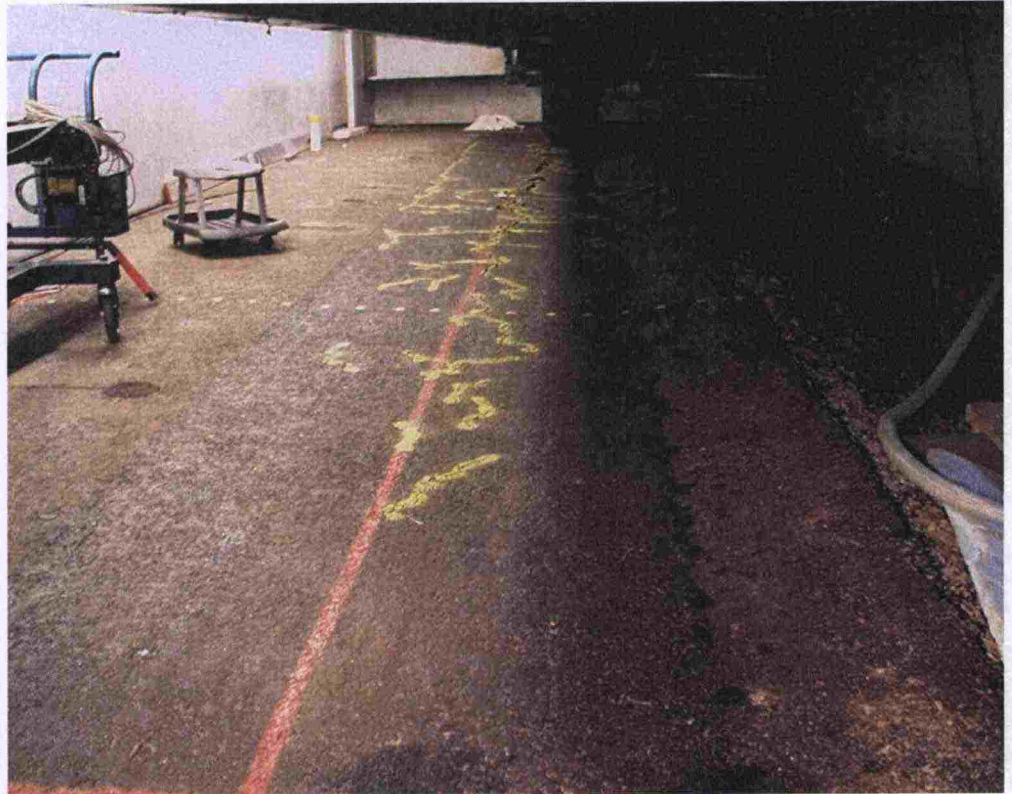
Figure 1. Cracks of the entire structure. Slope on right.

Distress surveys were made on the top of the surface layer immediately after the first cracks appeared. Subsequently, the damage was surveyed after each loading phase. The damage was recorded on maps, which indicated when they appeared and the corresponding loading figure. Only some minor damage (short, narrow cracks) was observed in structures with no slope or gentle slope. The structure with steep slope, however, showed significant

cracks, with the largest appearing behind the rut. Appendix 17 presents images of the damage in the structure with steep slope.

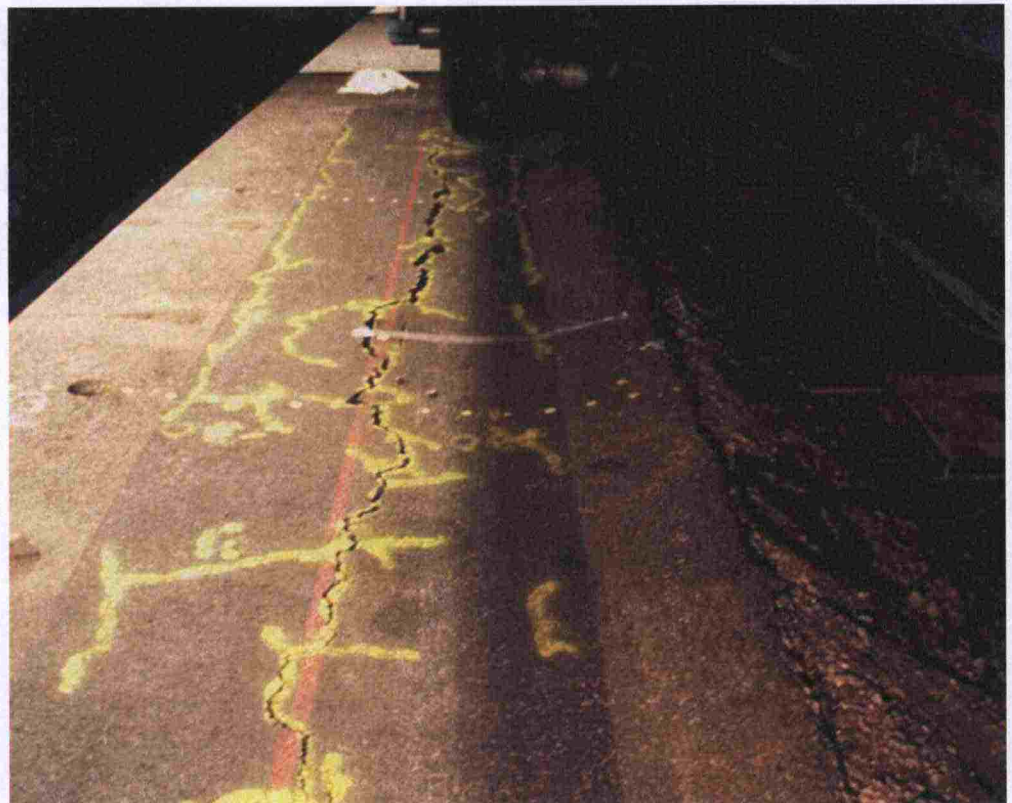
Figure 2. Cracks of middle part of structure.
